Well, well,

The excavation of two wells on New Walk Terrace, York 1999

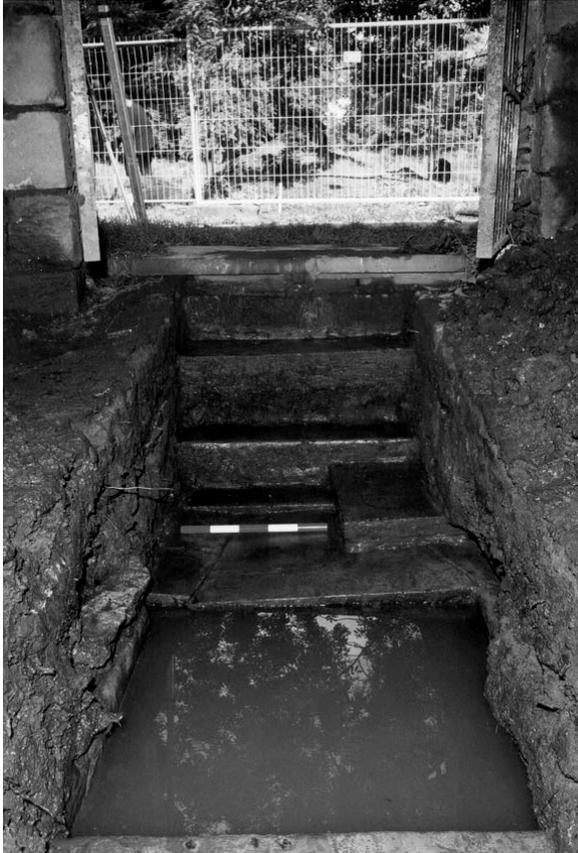
Trench 1 extended from the front gates to the rear wall of the well-house building. The earliest excavated levels consisted of a flight of steps leading to a paved floor, surrounding a stone-lined pool, which almost certainly formed part of Thomas Pickersgill's restoration

Figure 1. The interior of the well-house showing the central pool, flagged floor and flight of steps

The flight of four steps which led downwards from west to east was located immediately inside the entrance gate of the well-house. The steps were of differing heights, ranging from only 0.03m to 0.35m. It is possible that when the well was re-erected by Pickersgill the original steps were carelessly re-laid giving a flight of steps with variable risers. The third step had a small socket and a lug on the upper surface, which presumably related to earlier gates of the building. To the east of the steps was a floor of flat paving stones surrounding a rectangular pool, which was located centrally within the well house. The pool measured 0.80m x 0.99m and was lined on all four sides with stone slabs. The water table within the pool was only 0.05m below the level of the paved floor, consequently the pool filled with water to this level no matter how much infilling material was removed from the well. The standing water made it impossible to excavate fully the interior of the well, but probing suggested that the stonework lining of the pool continued downwards for at least 1.00m.

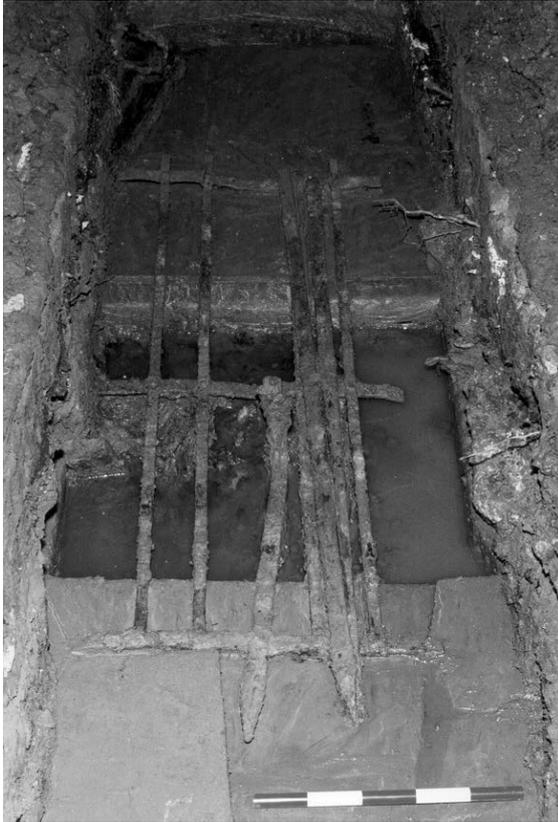
containing bricks, limestone rubble and numerous fragments of modern bottle-glass. A wooden plank and a section of wrought iron fencing were then placed horizontally across the well-house floor (Figure 2). Concrete paving slabs were then laid above the iron fencing. The well had been effectively infilled and capped, preventing any further use.

Figure 2. The interior of the well-house with the re-used wrought-iron fencing sealing the well

The section of wrought iron fencing was of considerable interest. It consisted of seven uprights (two of which had become detached) and three horizontal sections. Three of the uprights culminated in a point and were thus longer at the top than the two groups of two uprights that evenly separated them. Conservation work on the fencing revealed part of a foundry tag plate attached to the first upright. Although approximately 25% of the tag plate was missing, after cleaning it became possible to clearly see an inscription which read – *MPSON – WALKER UNDER TO THE QUEEN ORIA WORKS YORK*. When the missing letters were filled in, this read as – *THOMPSON – WALKER IRONFOUNDER TO THE QUEEN VICTORIA WORKS YORK*. The lettering is in a fairly regular script and was in relief, having presumably been cast as a mould. The foundry tag plate made it possible to identify where the fencing was manufactured. William Thomlinson Walker began constructing his foundry ‘empire’ in 1853, in premises near the Foss. His business thrived throughout the second half of the nineteenth century and he was able to employ a large workforce

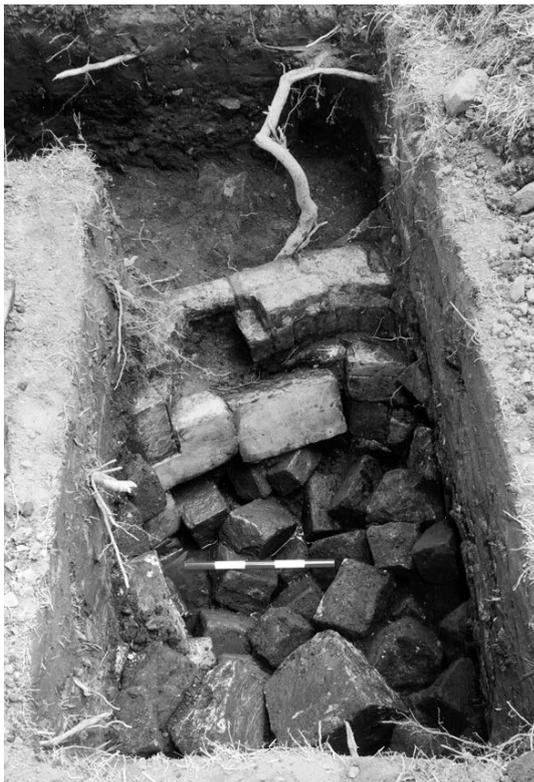
Trench 2 was located to the west of the well-house, on the grass verge between the River Ouse and New Walk. The trench was excavated to locate and assess the state of preservation of the crescent shaped 'open receiver' building shown on the 1852 Ordnance Survey map. The earliest deposit excavated was a curving wall, the outer face of which was of brick, and the inner face of carefully dressed limestone blocks 0.20m wide (Figure 3).

Figure 3. The 'open receiver' and deliberate infilling

This structure clearly represents part of the 'open receiver' well shown on the 1852 Ordnance Survey map. Four courses of stonework roughly 0.80m high were excavated; the lowest two courses had a deliberate gap in the masonry 0.77m in width, into which the third course of stonework had partially collapsed. The deliberate gap could represent the mouth of a culvert leading into the open receiver. Butting against the eastern side of the wall was an associated compact gravel surface, which had slumped by 0.35m in a linear east-west band 0.70m wide. This linear slumpage ran directly towards the gap in the lower courses of stonework in the wall, and may imply a collapsed linear feature beneath, possibly a culvert.

The open receiver had clearly been deliberately infilled with a massive dump of carefully dressed limestone blocks, presumably from the walls of the open receiver. It is unclear when this occurred, but it may have been in 1929 when Pikeing Well was closed. Dumping then occurred above the open receiver and its related gravel path in order to raise and level the ground surface in the area. The dumping was clearly modern, as one context contained a 1971 penny. The area was subsequently levelled and a tarmac path with a kerbstone edge was built. The area was then sealed by a build-up of river lain deposits, topsoil and turf.
